#### CAPSULE SUMMARY

Patuxent River State Park

MIHP # HO-760/M:15-98

Montgomery and Howard Counties, Maryland

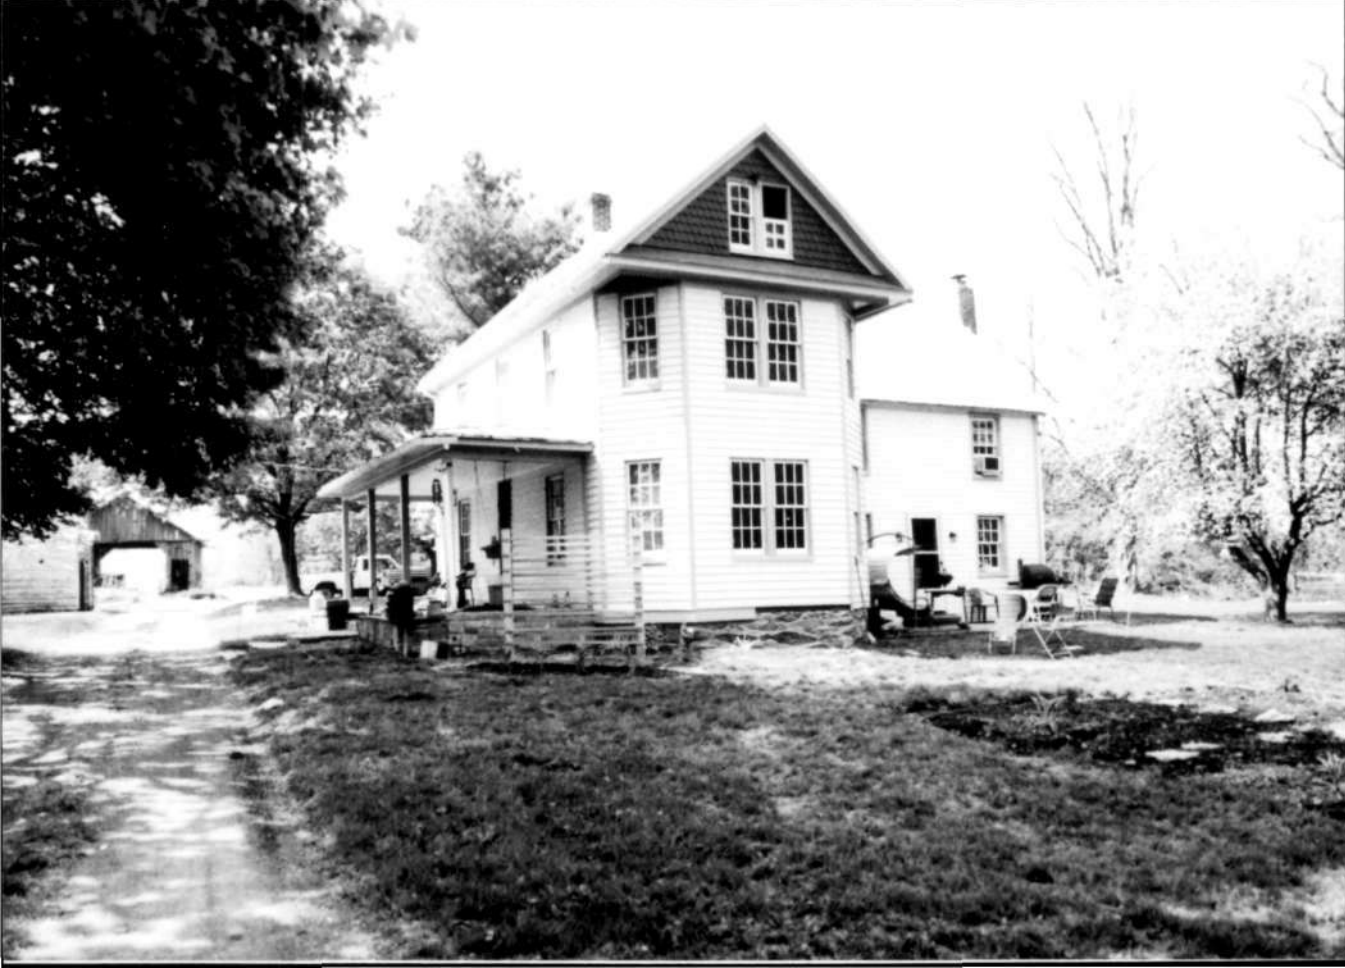
2/35

R. depley / Bowman Farm hse HO-544,  
looking NW

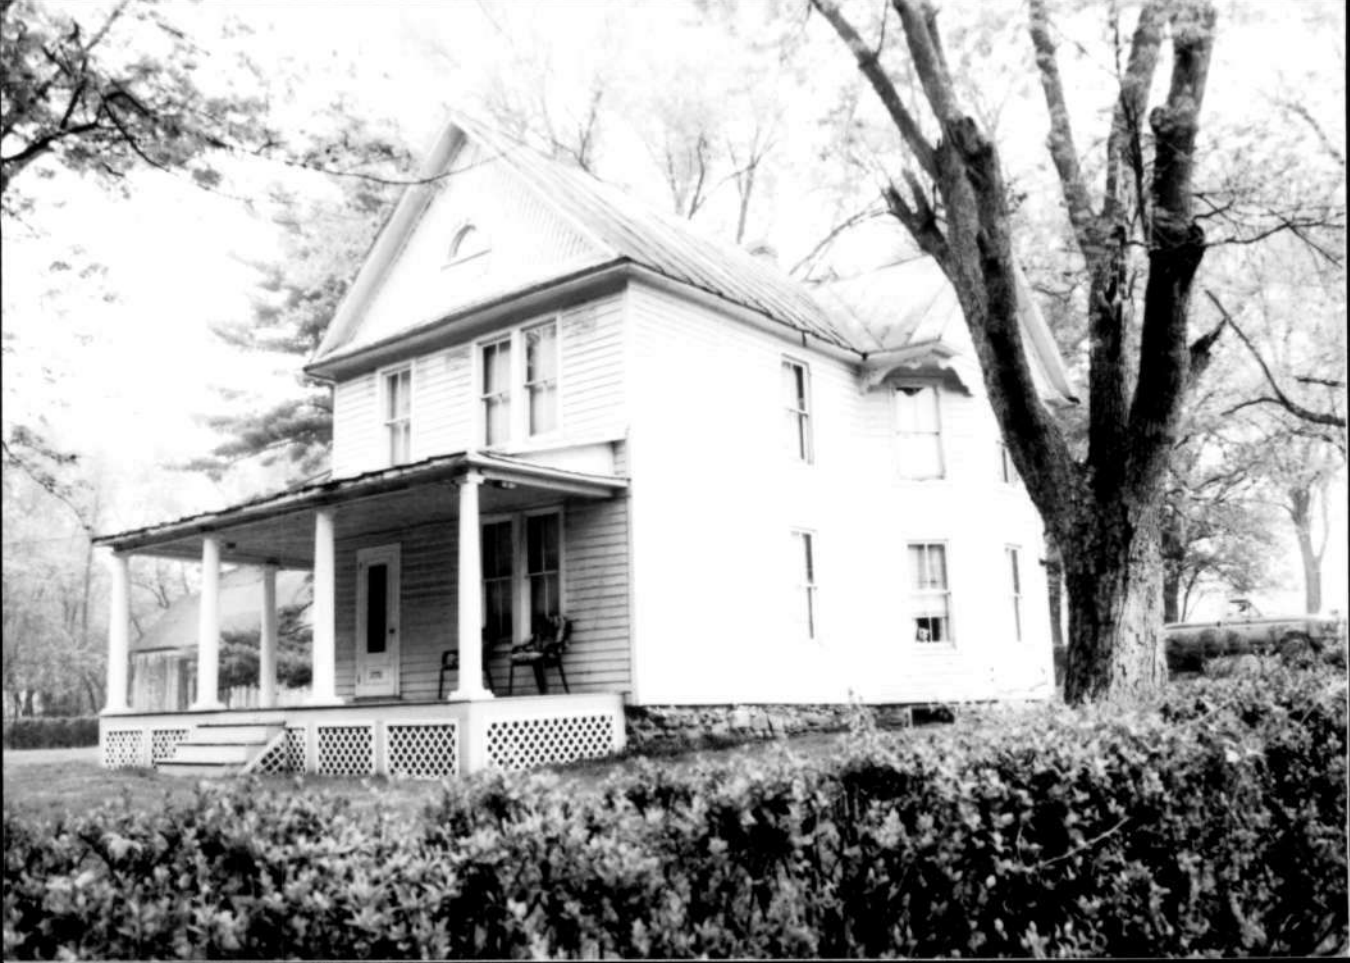
8/35

The Driver Farmhouse is a two-story, three-bay, wood-frame farmhouse that occupies a T-shaped ground plan. It was constructed between 1883 and 1909 (Deale 1979; USGS Mt. Airy quad 1909) and exhibits at least three periods of construction. The house rests on a stone foundation. Sections of the foundation have been replaced with concrete. The exterior is clad with horizontal wood siding with cornerboards between the wing and the main block. Fishscale wood shingles are located on the cross-gable of the southwest elevation. The cross-gable roof is sheathed in standing-seam metal. The eave has a boxed cornice and pedimented

Driver farmhouse Ho-546,  
looking N

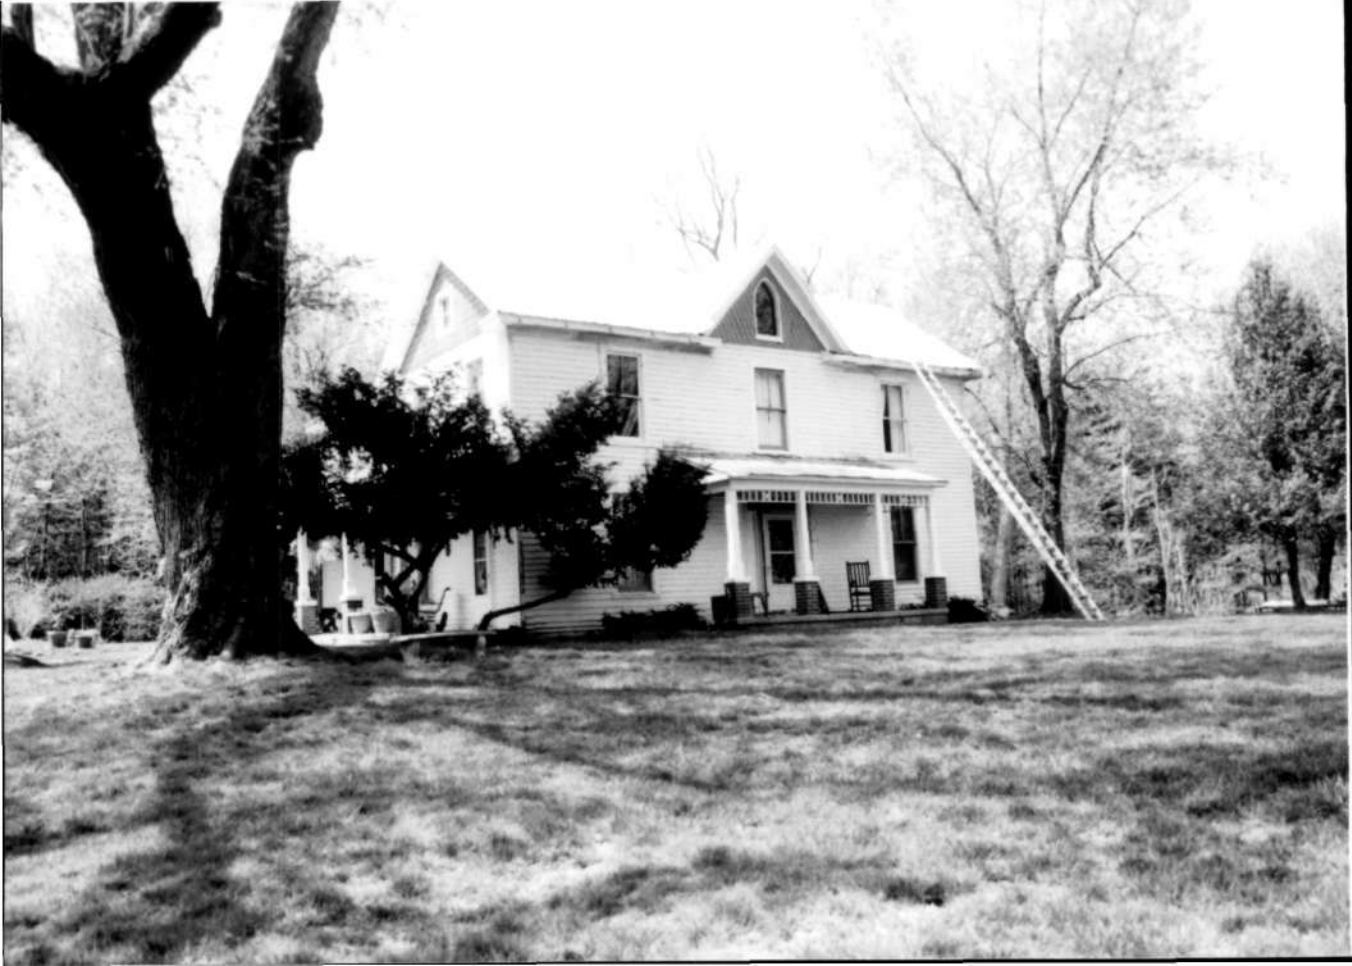
10/35

The Former HILTON FARMHOUSE (MIHP # HO-746), constructed between 1883 and 1909 (Deale 1979; USGS Mt. Airy quad 1909) is located west of Annapolis Rock Road at 3780 Woodbine Road. The wood-frame, two-story house occupies an L-shaped ground plan. Each section rests on a stone foundation. The building has three bays on the east elevation and four bays along the south elevation. The exterior cladding is primarily horizontal wood siding with asbestos shingles installed on the eastern elevation. The intersecting gable roof is sheathed in corrugated metal. The east elevation features a fishscale-shingled central gable peak with a lancet window. The eave features a boxed cornice and gable-end returns. The main entry in the east elevation is centrally located and contains a wood door with a large glass pane. A fixed, single-light transom has been fitted over the door. Sidelights have been boarded over. A wood storm door fitted with two full-length panes has been installed over the main entry. The main entry opens onto a single-bay, wood, front porch that rests on a stone foundation and is covered with a standing-seam metal roof supported by wood posts. Windows in this section of the building are simple wood-frame, two-over-one-light, double-hung sash units installed in 1997 (MdDNR DMI 2002). An ell has been constructed off the southwest corner of the main block. This two-story, wood-frame addition also rests on a stone foundation. The gable roof is sheathed with corrugated metal. An interior brick chimney is located on the rear interior roof ridge. The door has a four lights and three wood panels. This door is covered with an aluminum, two-light storm door. Windows in the ell are two-over-one light, double-hung sash units installed since 1997 (Mazurek 1997). A more than full-ell-width concrete slab porch with brick based wood supports adjoins the south elevation and extends north beyond the ell almost to the southeast corner of the main block. A shed addition has been constructed on the west elevation of the ell. The shed is rectangular and rests on a concrete-block foundation. The walls are clad with T1-11 siding and the roof is sheathed with corrugated metal. One-over-one and nine-over-nine-light windows illuminate the interior while a fifteen-light door provides entry to the addition. The condition of the former Hilton House is good and it is in the process of repair by a curator. The rear elevation siding needs paint and the standing-seam metal roof over the front porch is rusting.

Hilton Farmhse Ho-746  
looking NW

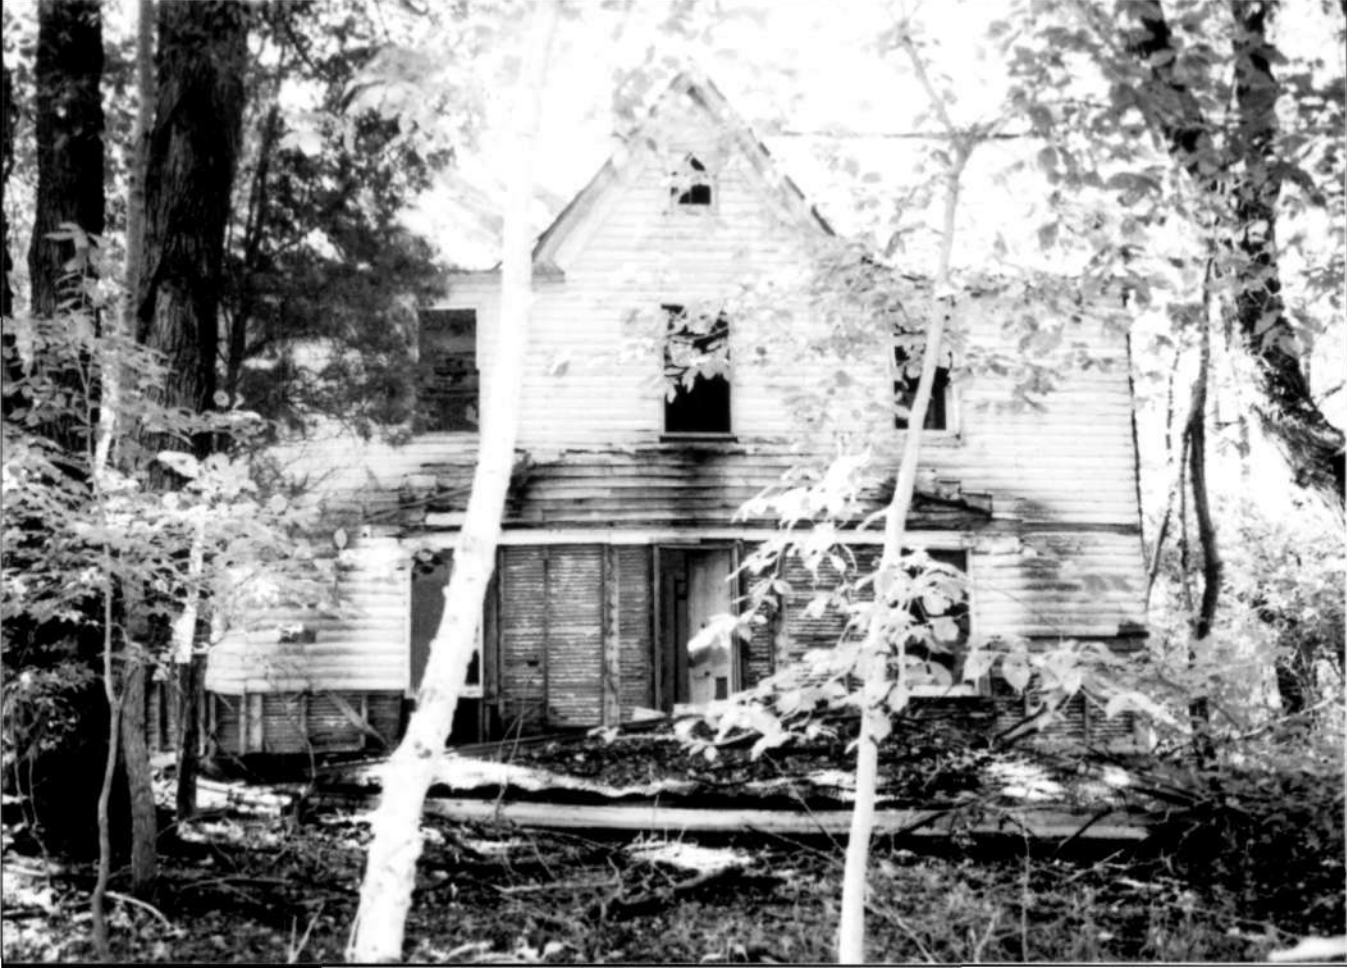
12/35

The H. E. CHROBOT FARM is located at the end of a long overgrown lane accessed from the south side of Jennings Chapel Road. The ca. 1900 farm features a two-story dwelling, a barn foundation, an animal pen, five sheds, and an ice pit. The ruinous condition of the house and agricultural outbuildings have compromised the complex's integrity of design, materials, and workmanship to qualify for listing in the National Register of Historic Places under Criteria A and C.

The two-story Chrobot dwelling is an L-shaped wood-frame building resting on a stone foundation. A basement is located under the east half of the house. The dwelling features a combination of hewn wood sills and sawn mortise-and-tenon and balloon wood framing. The walls are clad with wood clapboard and the gable roof is sheathed with metal. The roof has gable returns, a center brick chimney, and a rear interior chimney. The principal block is three bays, two-rooms wide and one-room deep. The east elevation features a three-sided, two-story bay. A hipped roof porch once protected the central entrance and its four-panel door. A three-bay deep, two-story ell featured a curved staircase. An enclosed porch was located along the west elevation of the ell. A ca. 1920 bathroom was located near the rear elevation of the ell. The one-story, gable roofed building had a concrete bathtub. The house is in ruinous condition. The roof and the center of second floor of the rear ell and the front porch have collapsed. The walls are deteriorated, the windows are missing, and the stone foundation is falling apart.

4.E. Chrobot Farm off  
Jennings Chapel Rd,  
View N

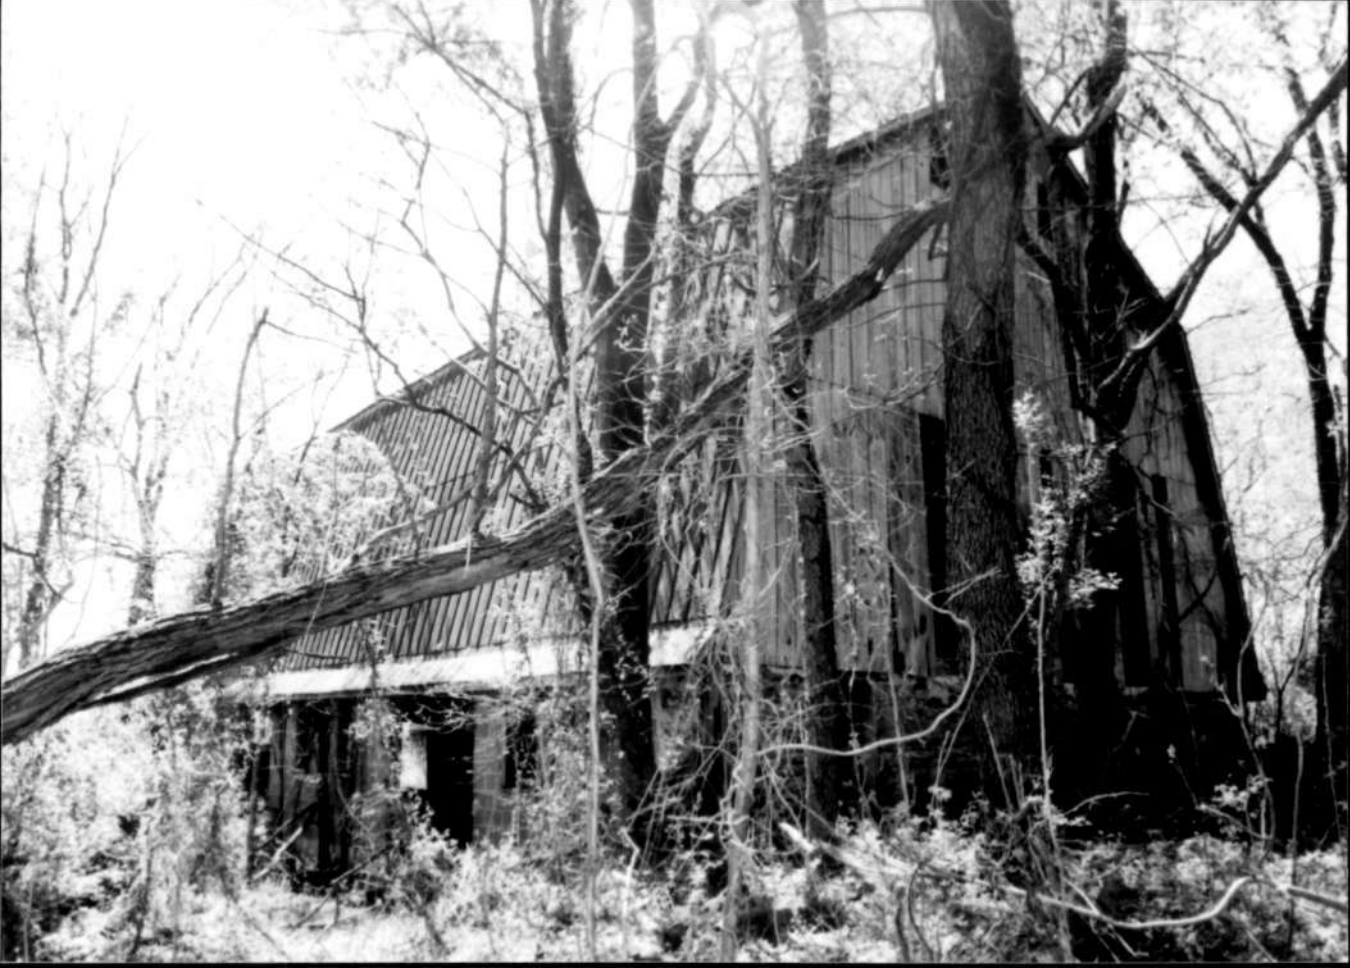
14/35

A Bank Barn constructed circa mid-twentieth century is located southwest of the house. The foundation wall along the west elevation is stone, but has been repaired with concrete wall sections. The lower wall along the east elevation overlooking the paddock is constructed of concrete and concrete block. The upper portion is wood-frame and the end elevations are clad in vertical wood siding above the foundation and in horizontal wood siding along the lower level. The shallow gambrel roof sheathed in standing-seam metal extends to the foundation walls on the east and west elevations. The west elevation (banked) has a central gabled dormer located over the main entry. The main entry contains a set of large, swinging, wood-board doors. This dormer has fascia installed in the gable eave. Three empty doorframes and six empty window frames are located in the lower east elevation facing the yard. Empty wood window frames also are located in the upper gable ends. The condition of this barn is poor. The foundation mortar is eroding and stones are loose. Cracking is evident in the concrete-block sections. The interior flooring is collapsing. The roof is rusting and the wood board siding in the gable elevations is deteriorating.

Barn of Ho-745  
looking E

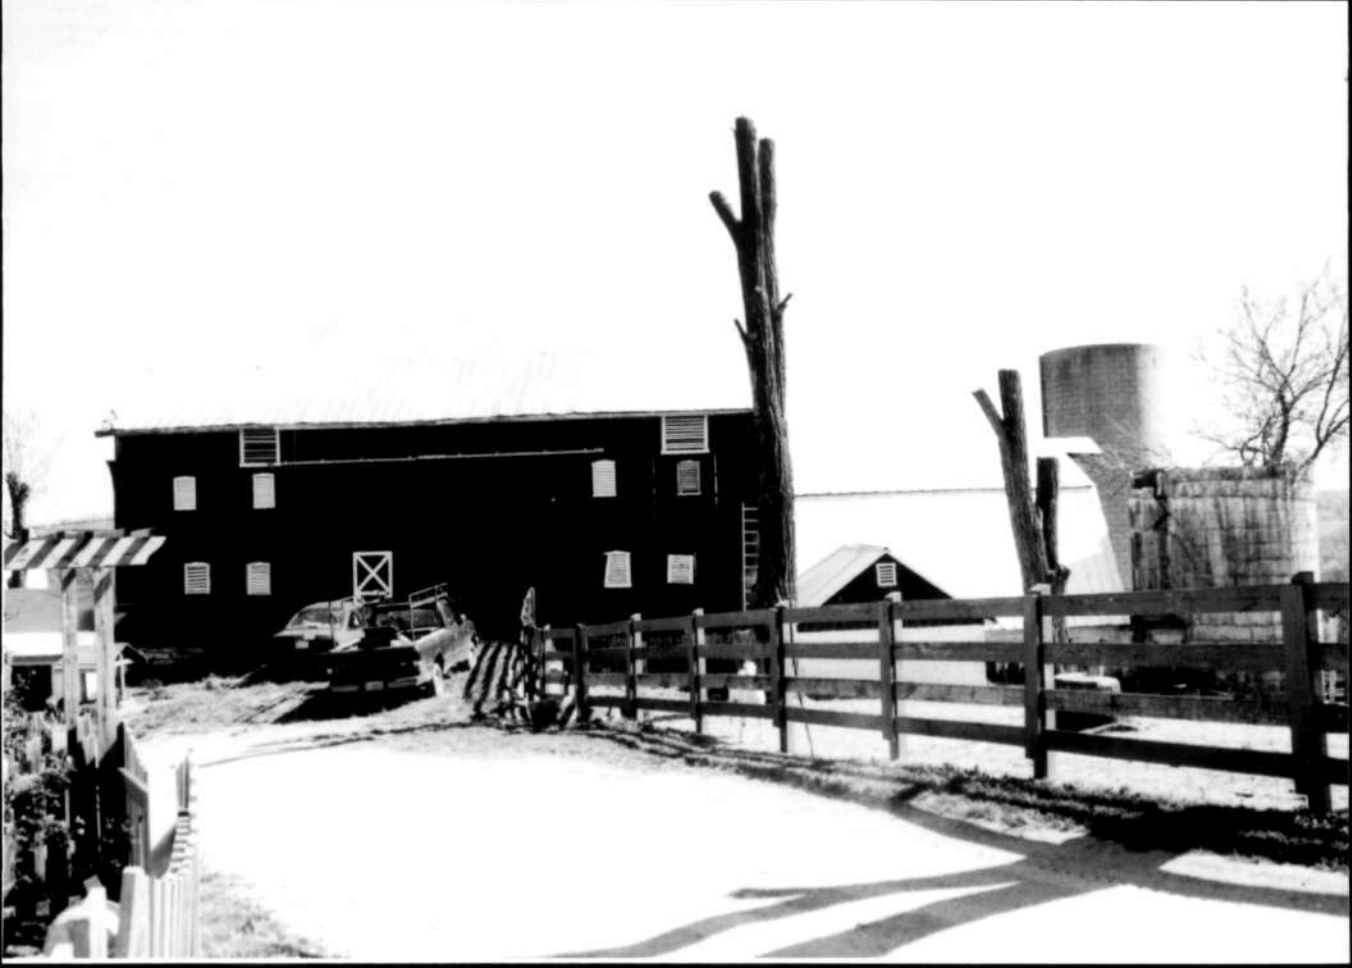
116/35

The ca. 1900 former Anderson Bank Barn is located west of the farmhouse; the bank is on the northeast elevation. The rectangular, wood-frame barn rests on a stone foundation and is clad with vertical wood siding. The gable roof is sheathed in standing-seam metal. Lightning rods have been installed along the roof ridge. Vents installed on the barn walls feature triangular pediments. The main entrance on the banked elevation contains twin sliding doors of vertical wood boards with a smaller, swinging door inserted into the lower left corner of the left door. Stone walls on either side support an earthen ramp that leads to these doors. Three mid-twentieth-century additions have been added to the bank barn. To the southeast, a one-story, concrete-block, gable roof shed has been added. This shed exhibits six-light hopper windows, the main entrance is a particleboard door. A milking parlor addition attached to the northwest elevation is one-story with concrete-block walls on a concrete slab. This addition has a gambrel roof covered with standing-seam metal. Two-light fixed windows illuminate the interior. A third addition is located in front of the gambrel roof addition and to the right of the main barn access ramp. This small, square addition rests on a concrete-block and slab foundation, has concrete-block walls and a gable roof that is covered with standing-seam metal. An open bay provides access to the interior. The condition of this barn complex is good. Some vertical boards are missing from the main barn, some wood vent slats are missing. Some lights are missing from the hopper windows. Paint is failing.

Anderson barn Ho-744, view  
S
